TP 185E
Issue 4/2009

AVIATION SAFETY LETTER

Inspection and Maintenance of Flush-Mounted Fuel Caps

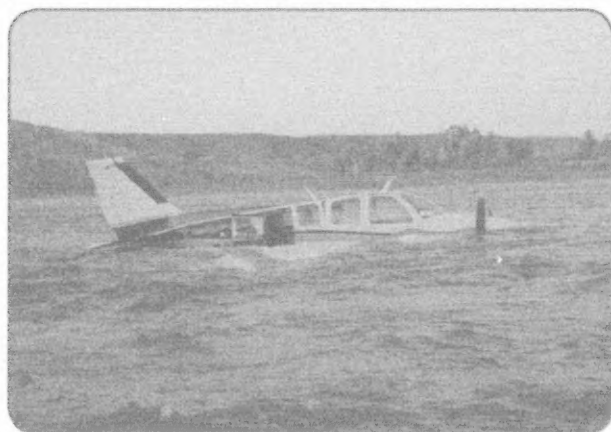
On September 17, 2008, a privately operated Beechcraft Baron 58 departed Medicine Hat, Alta., on a VFR flight to Fort St. John, B.C. Immediately after takeoff, the right engine (Teledyne Continental IO-520-C) surged and lost power. Power could not be restored and the engine was subsequently secured. The aircraft was unable to maintain level flight with the left engine operating at full power, and it descended and crashed into the South Saskatchewan River several miles from the airport at 19:25 Mountain Daylight Time (MDT). (See Photo 1.) The pilot and two passengers sustained minor injuries; two additional passengers sustained serious injuries. The aircraft was substantially damaged.

Photo 1: This Beech 58 Baron forced landed in South Saskatchewan River after the right engine lost power.

The right engine was removed and successfully run on a test stand. Subsequent visual inspection and flow check of the related fuel injection components, and detailed examination of the airframe fuel system, did not reveal any system abnormalities that would have precluded normal function. While the reason for the loss of

power was not identified during the assessment of the occurrence, indications of water contamination within the fuel system were noted.

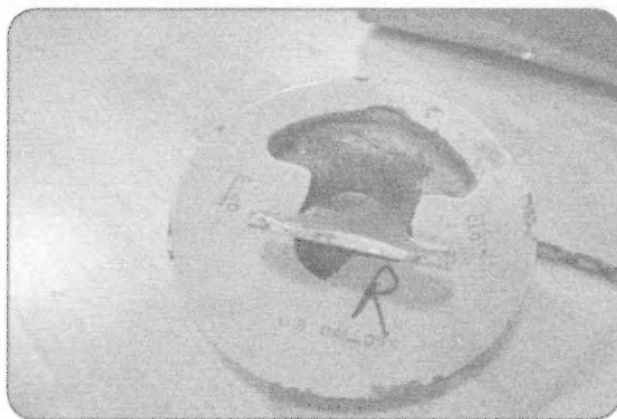
Photo 2: Top view of flush-mounted fuel cap

One potential pathway for free water, in the form of rain or wash water, to enter aircraft fuel tanks is through fuel caps that do not seal properly. The aircraft was fitted with two standard, flush-mounted fuel caps manufactured by Shaw Aero Devices¹. (See Photos 2 and 3.) This type of fuel cap is installed in numerous models of small aircraft. The cap seals consist of two O-rings, one around the outer circumference of the cap and one on the shaft of the locking mechanism axle. Water leakage was detected post-accident during in situ testing of the fuel caps, with the fuel caps secured in the filler openings. The handle bearing plates also showed excessive wear and the caps had parts missing.

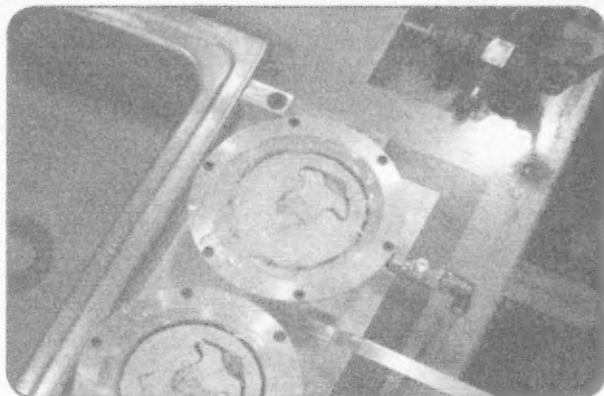
The fuel caps were forwarded to the manufacturer, where they were tested in accordance with Shaw Aero Devices standard acceptance test procedures for fluid filler caps and adapters. The procedure required the fuel caps to be mounted in a test fixture and 5 to 25 psi pressure to be applied to the underside. No leakage is permitted. At 0.5 psi, both caps leaked past the axle and handle assemblies. (See Photo 4.) The caps were disassembled and inspected. The O-rings on the axle shafts in both

Photo 4: Fuel caps on test pot—note air bubbles above cap in middle of picture that indicate leakage

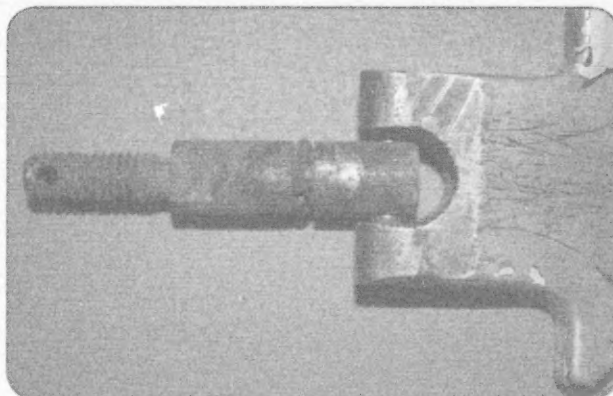
caps were cracked and broken, and both axle shafts were corroded sufficiently to indicate long-term exposure to moisture. (See Photo 5.)

Photo 5: Note deteriorated O-ring and corrosion on axle shaft

Neither the cap manufacturer, nor the aircraft manufacturer provides written guidelines for inspection and maintenance of this type of fuel cap. At least one other small aircraft manufacturer has developed detailed guidelines for inspection and maintenance of flush-mounted fuel caps. The Federal Aviation Administration's (FAA) Advisory Circular AC 43.13-1B, titled *Acceptable Methods, Techniques and Practice—Aircraft Inspection and Repair*, is a primary maintenance reference to be used when manufacturers do not supply repair or

maintenance instructions. AC 43.13-1B simply states that fuel cap O-rings are to be inspected to determine that they are in good condition. Furthermore, Shaw Aero Devices considers the fuel caps to be a "return to vendor" item if repair, including O-ring replacement, or overhaul is required.

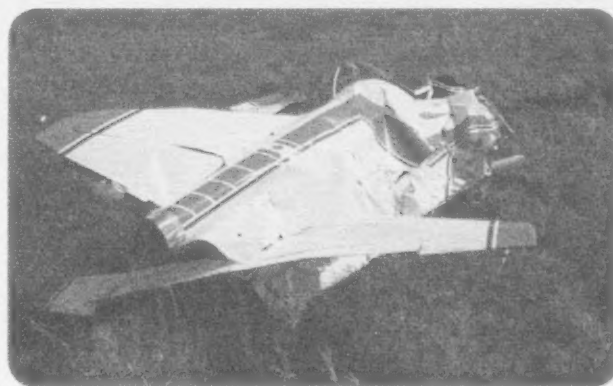
1. Loss of pitch control, consistent with an aft CG, occurred in gusty and turbulent conditions at a height too low for the pilot to effect recovery.
2. The cargo was unrestrained, which may have allowed some cargo to shift rearwards during the takeoff and climb, resulting in an extremely aft CG.

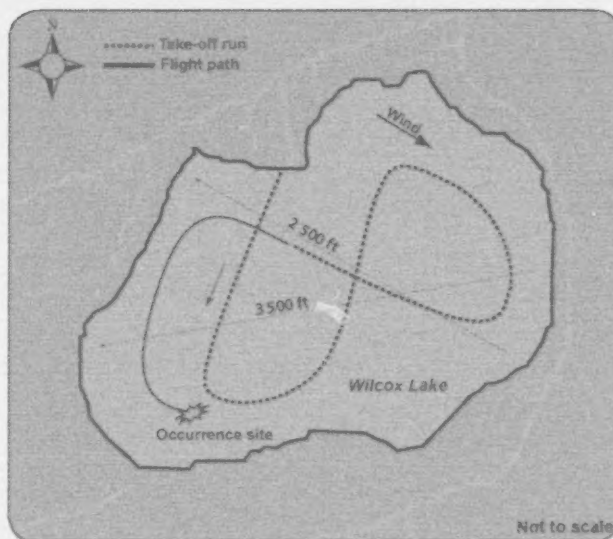
1. The right flap was incorrectly installed during the wing installation, which allowed the right flap to retract during the fly-past. This created a flap asymmetry that resulted in an uncommanded and uncontrollable right roll. The aircraft was at an altitude from which recovery was not possible before the aircraft struck the ground.

1. The right-wing taper bolt did not penetrate deep enough through the spars to engage the fibre locking feature of the locknut. Therefore, the taper bolt was not in safety at the time of the accident.
2. The fibre locking feature of the left-wing locknut was worn and did not secure the left-wing taper bolt in safety.

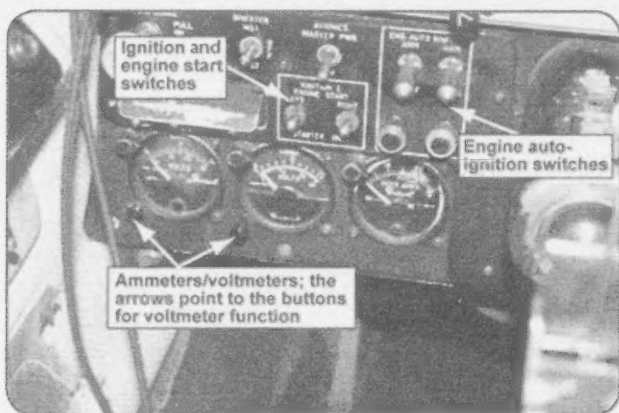
TSB Final Report A06Q0180—Loss of Electrical Power

On October 18, 2006, a Beechcraft King Air 100, with two pilots and four passengers on board, took off at 09:18 Eastern Daylight Time (EDT) from the Montréal/Pierre Elliott Trudeau International Airport, Que., on an IFR flight inbound to Montréal/St-Hubert Airport, Que. Shortly after takeoff, the generation of electrical power ceased, followed by a complete loss of radio navigation equipment, some flight instruments, most engine instrument panel indicators, and a radio communication failure. The crew left the assigned altitude to descend to the minimum sector altitude. A break through the clouds allowed the aircraft to descend below the cloud cover. The crew continued the flight under VFR, and the aircraft landed without further incident at the Montréal/St-Hubert Airport. There were no injuries or damage to the aircraft.

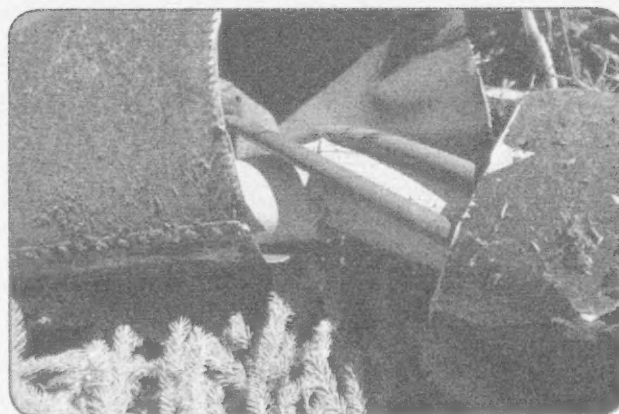
TSB Final Report A08W0096—Loss of Control and Collision with Terrain

On May 24, 2008, a MacDonnell Douglas Helicopters Inc. (MDHI) 369D helicopter was transporting drilling personnel near Doctor Lake, N.W.T. Near the landing site, the pilot had been hovering into wind at approximately 300 ft above ground level (AGL) to determine the best footpath between a water body and a landing pad; once this had been accomplished, the aircraft was in the process of descending and hovering sideways to the left with the nose into wind toward the landing pad. At about 75 ft AGL, the aircraft started an uncommanded rotation to the right and crashed. The helicopter was substantially damaged by impact forces

and a post-crash fire. The pilot was seriously injured, one of the two passengers was fatally injured, and the other suffered minor injuries.
